Silver Firs HOA
Everett, WA

Report #: 21887-1
Beginning: February 1, 2023
Expires: December 31, 2023

RESERVE STUDY
Update "With-Site-Visit"

October 25, 2022

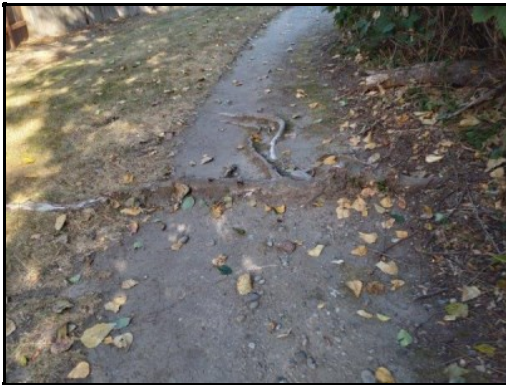
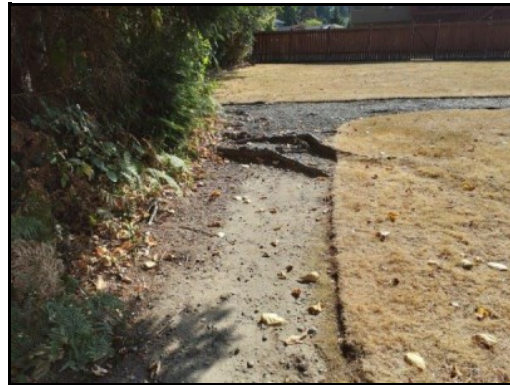
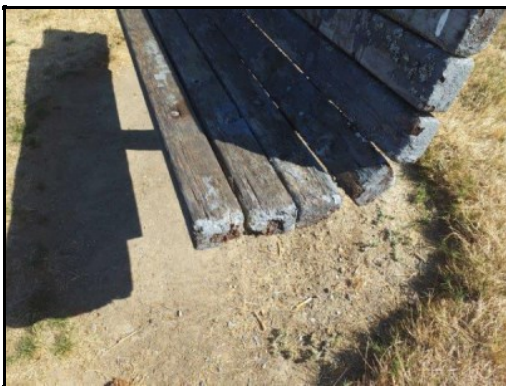
The below photo illustrate observations of exposed roots at nature paths and advanced deterioration of site furniture.

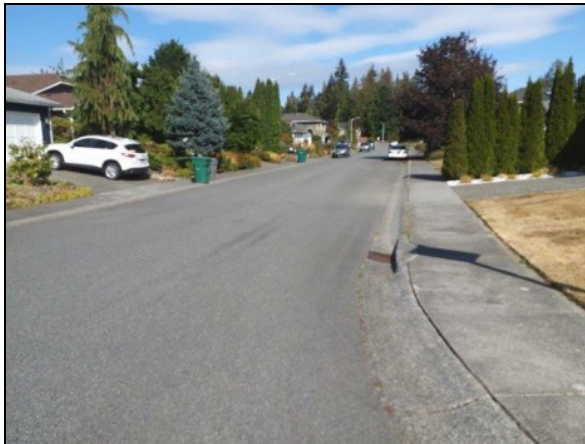
Comp #: 100 Concrete - Repair/Replace

Location: Mostly adjacent to community streets
Funded?: No. Annual costs best handled through operating budget
History: None Known
Comments: The concrete appeared in generally stable condition, with no significant deterioration at this time.

The majority of walkways and curbing installations are adjacent to individually owned lots, in which the responsibility for repairs/replacement falls upon the Lot Owner(s), not the Association. The annual repair needs for the areas within Association responsibility are below typical reserve funding thresholds (1% or more of total annual expenses), and should be factored into the operating budget.

As routine maintenance, inspect regularly and pressure wash for appearance. Repair any trip hazards (1/2" difference in height) immediately to ensure safety. Repair promptly, as needed, to prevent water penetrating into the base, which can cause further damage. Factors affecting the quality and service life of the concrete include the preparation of the underlying soil and drainage, thickness and strength of the concrete used, steel reinforcement (none likely), amount and weight of vehicle traffic, and tree roots.

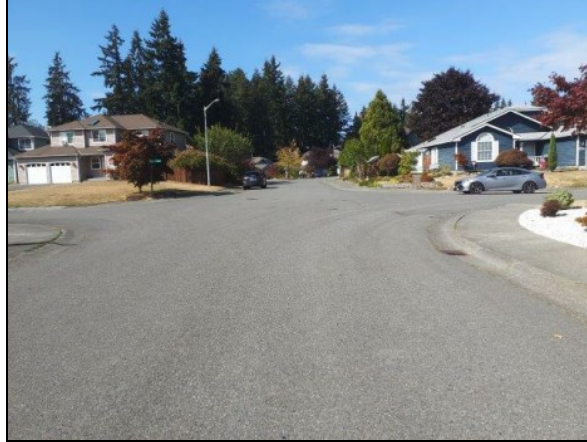
Comments: The asphalt appeared in stable condition, with no widespread problems like cracking, excessive wear, alligator cracking, etc observed during our limited visual review.

The community streets are dedicated public right of ways, The responsibility for maintenance, repairs and replacement falls upon the local municipality, not the association. Therefore reserve funding is not warranted.

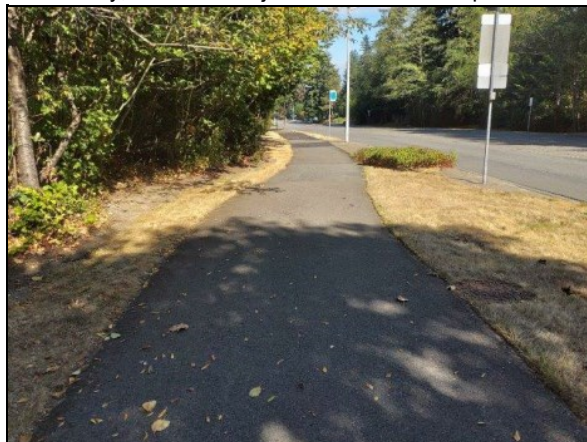
Comp #: 123 Asphalt Path - Partial Replace

Comments: The asphalt appeared in stable condition, with no widespread problems like cracking, excessive wear, alligator cracking, etc observed during our limited visual review.

In prior study updates, we had excluded funding as this path was reported to be the responsibility of the local municipality. Due to differed maintenance, issues related to upheaval and cracking, the Association elected to refurbish this path in 2022. With the anticipation of future large scale expenses by the Association for similar work, we have included the below allowances based in 2022 expenses. Track expenses and history, and make adjustments to this component in reserve study updates, if needed.

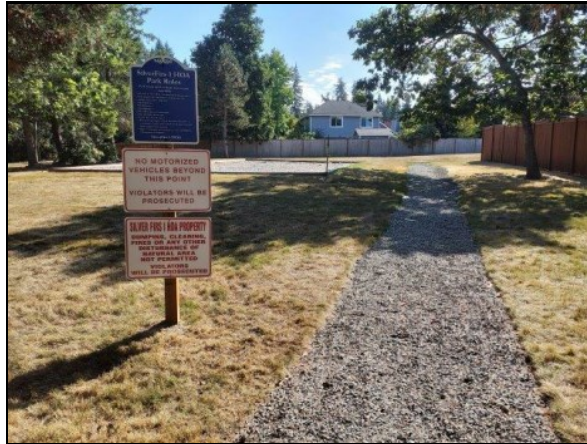
Comments: Trails within the community were noted in varied condition. Some areas have gravel fill; however majority are exposed soil. Some exposed roots were noted with may pose tripping hazards.

Fair coverage with no major depressions observed were noted in areas with gravel fill. The profile and drainage appear adequate. Although ongoing refurbishing/replenishment should be part of an annual maintenance program, we recommend including a funding allowance in reserves for periodic larger projects to maintain/rebuild some of these areas; these project may also include vegetation management and root removals. Track expenses and history, and make adjustments to this component in reserve study updates, if needed.
